CASE STUDY

Mine Pit Lake Treatment, South Australia

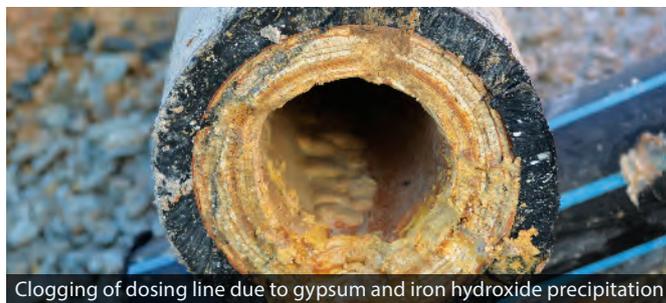
Clogging of dosing line due to gypsum and iron hydroxide precipitation

Earth Systems offered continued support during treatment undertaken by the client and tackled operational challenges, such as blockage of pipes and dispersion assemblies efficiently.

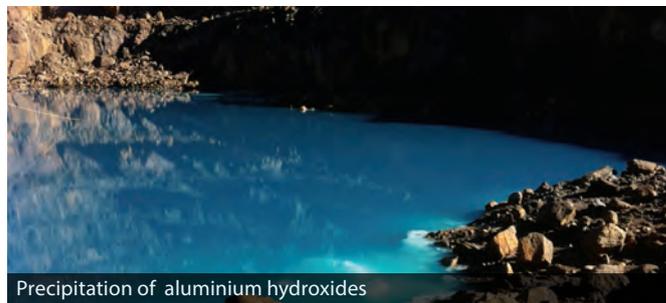
Precipitation of aluminium hydroxides
